BAB SHAMS POLICE STATION  
MOSUL, IRAQ

SUSTAINMENT ASSESSMENT

**SIGIR PA-06-091**  
**APRIL 25, 2007**

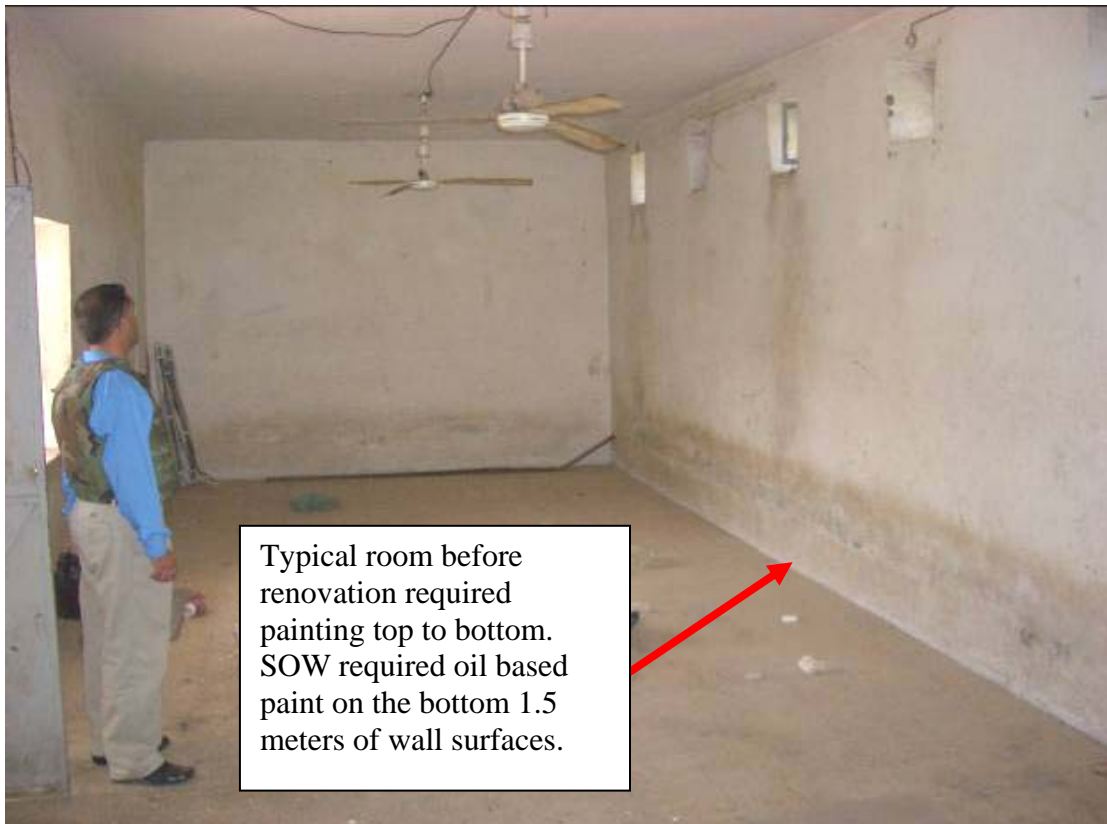
**USACE Pre-Construction Photo 7.**

The renovation also required the contractor to paint interior rooms and place tile on all steps. The SOW specified that oil based paint was to be used on the lower 1.5 meters of walls. USACE Pre-Construction Photo 7 shows a typical room in need of new paint while unsealed concrete steps are shown in USACE Pre-Construction Photo 8.

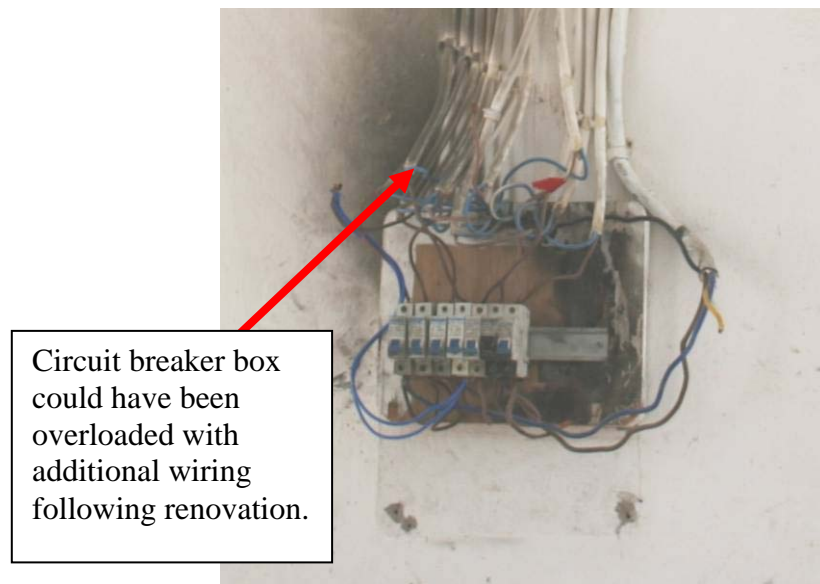
**Site Photo 17.**

- USACE Construction Photo 6 documented that a circuit breaker box was properly installed and covered. Based on Site Photo 17 taken at the same spot, it appears that added circuits/wiring could have resulted in a breaker box overload and fire. As a result, some “jury-rigged” circuits are now direct wired and not protected by a circuit breaker.

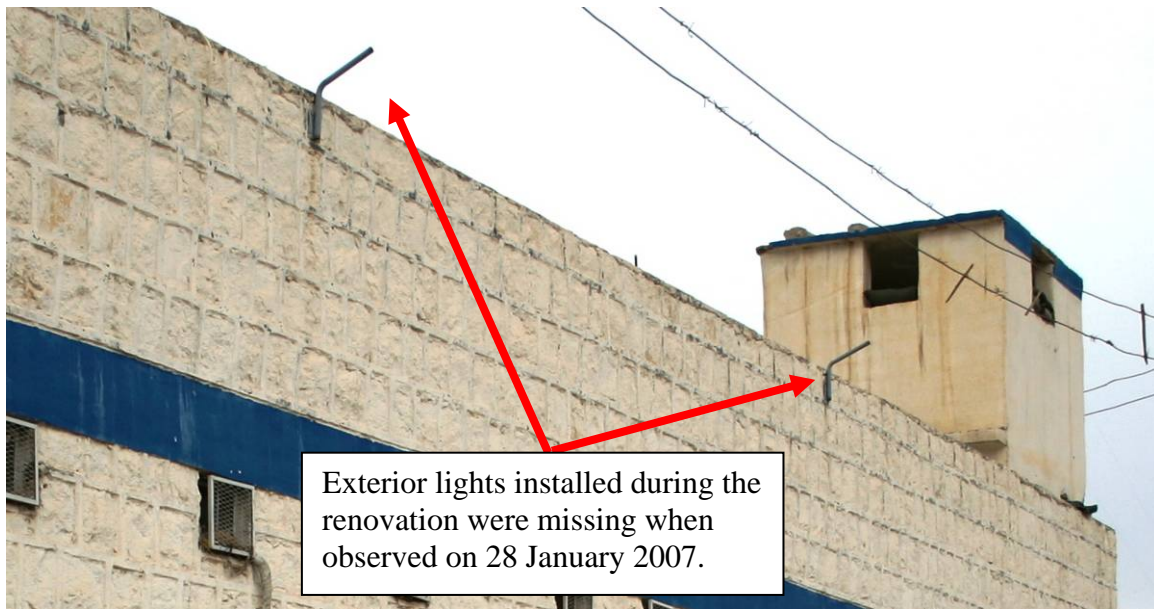
Site Photo 18.

- USACE Construction Photo 9 shows that exterior lighting was installed by the contractor in accordance with SOW requirements. However, the lighting does not appear in Site Photo 18, which was taken at the same spot. SIGIR inspectors observed similar instances of missing lighting.
